EFFECTS OF CONSTRUCTION TOLERANCES ON EXTERIOR WALLS

MATTHEW ALEXANDER AUGUSTUS MIS

DEGREE OF MASTER OF SCIENCE

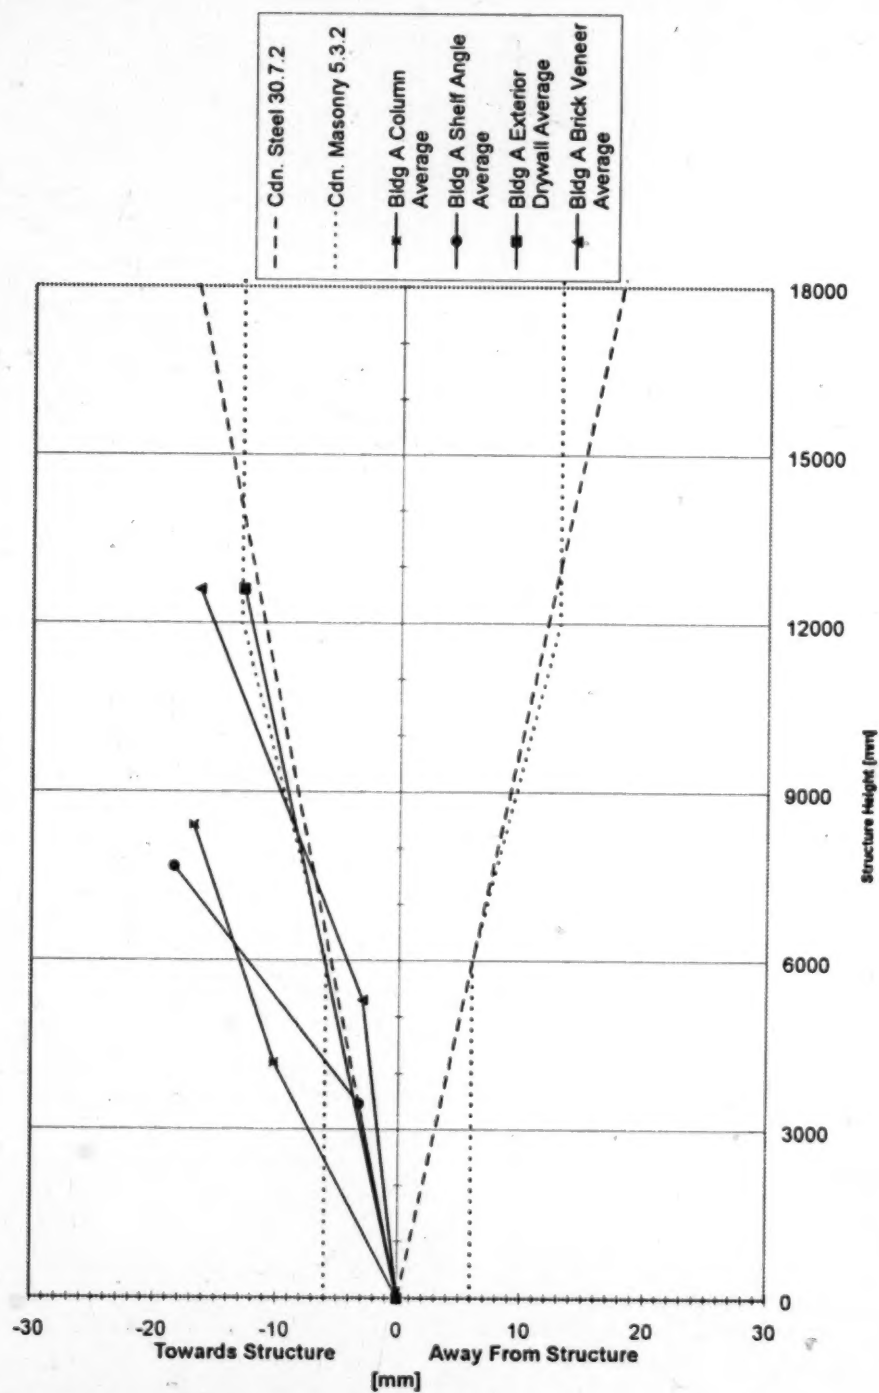
Figure 4.1 Out-of-plumb data for Building A.

The values for the plumbness of the columns can be found in Table 4.1, with the associated plot in Figure 4.1. By examining the numbers, one can see that the columns are leaning towards the structure, and are not even close to the set tolerance limits. At 4200 mm they are already out by 6 mm, and at 8400 mm the problem progresses to 8 mm past the limits (note that roof level values were not taken due to site access limitations). The standard deviations of both sets of values are around the 10 mm range. Maximum and minimum values are about 2 mm and -35 mm respectively (a negative value indicates leaning towards the structure off the centre line).

Table 4.1 shows that 68% of the values at 4200 mm and 83% at 8400 mm are outside of the set tolerances. Note that the Canadian concrete code recommends that 90% of the construction should fall within the tolerance limits. The remaining 10% is only conditionally acceptable, but may be used in the final structure if the defects are remedied to the degree that the completed job will comply with the tolerance of the finished project. It is obvious that the steel erectors did not do a sufficient job in erecting the columns, and considering that this building is only three storeys high, it is worrisome to think what might happen if the structure were taller.

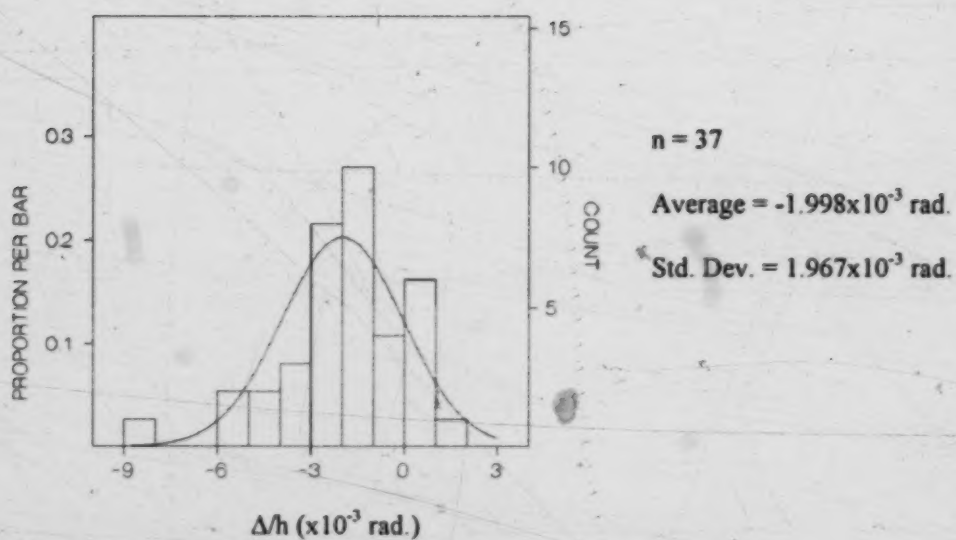
Figure 4.4 Steel column out-of-plumb distribution for Building A.

If one views the histogram in Figure 4.4, the mean plumbness value is -1.998×10^{-3} Rad., with a standard deviation of 1.967×10^{-3} Rad. By comparing this data to the data gathered by Beaulieu and Adams (Table 2.1), one can see if the size of the deviation is above or below their findings. Their mean and standard deviation values were found to be -0.044×10^{-3} Rad. and 1.62×10^{-3} Rad. for two of the steel buildings that were 27 and 34 storeys in height. This indicates that the columns from their structures had less deviation from vertical, and the entire sample was less spread out.

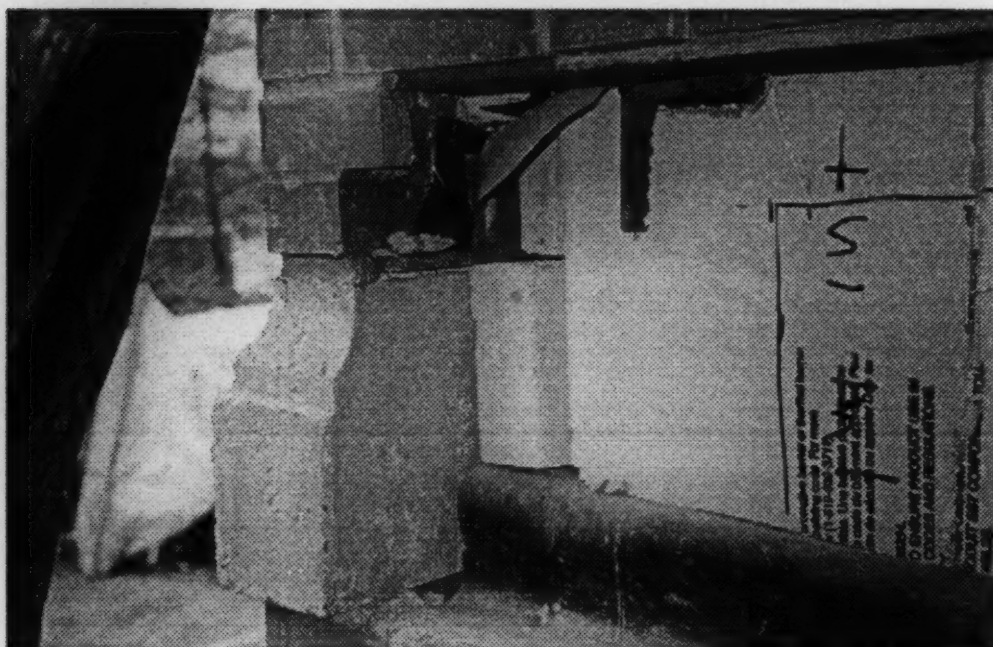
4.2.6.1 Improper Shelf Angle Placement

Although comments from contractors are open to bias, in this case they seemed to agree with observations found in the data. In some sections of the wall, particularly at the lower levels, the masons had to do away with the soft-joint below the shelf angle and place mortar in it because the bricks were not sitting at least half way on the angle. Figure 4.1 supports this, as it indicates that the shelf angles were installed closer to the structure as they increased in elevation.

Figure 4.25 Shelf angles installed 135 mm higher on southern elevation of Building A.

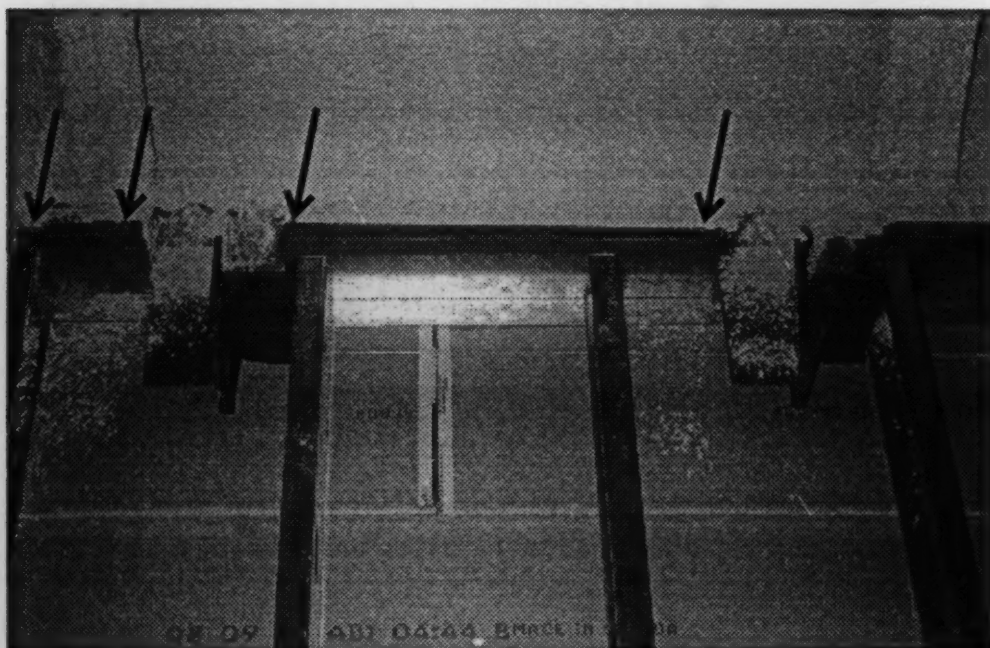
Figure 4.26 shows the final area of the exterior wall assembly that was shown to have problems. The expansion tracks located at the tops of the steel stud walls should not have been screwed together (indicated by arrows). This is most likely the result of the contractor failing to remove them after building the wall assembly. Not removing these screws prevents the walls from being able to move as freely as intended. Note, however, that some movement is still present because the screws are located on only one side of the track.

Figure 4.26 Screws installed in expansion tracks of Building A.
